FORMER EL PASO SMELTER SITE
 EL PASO, TEXAS

**NITRATE DISTRIBUTION IN SURFACE WATER
 FALL 2010 AND FALL 2011**

**FIGURE
 4-83**

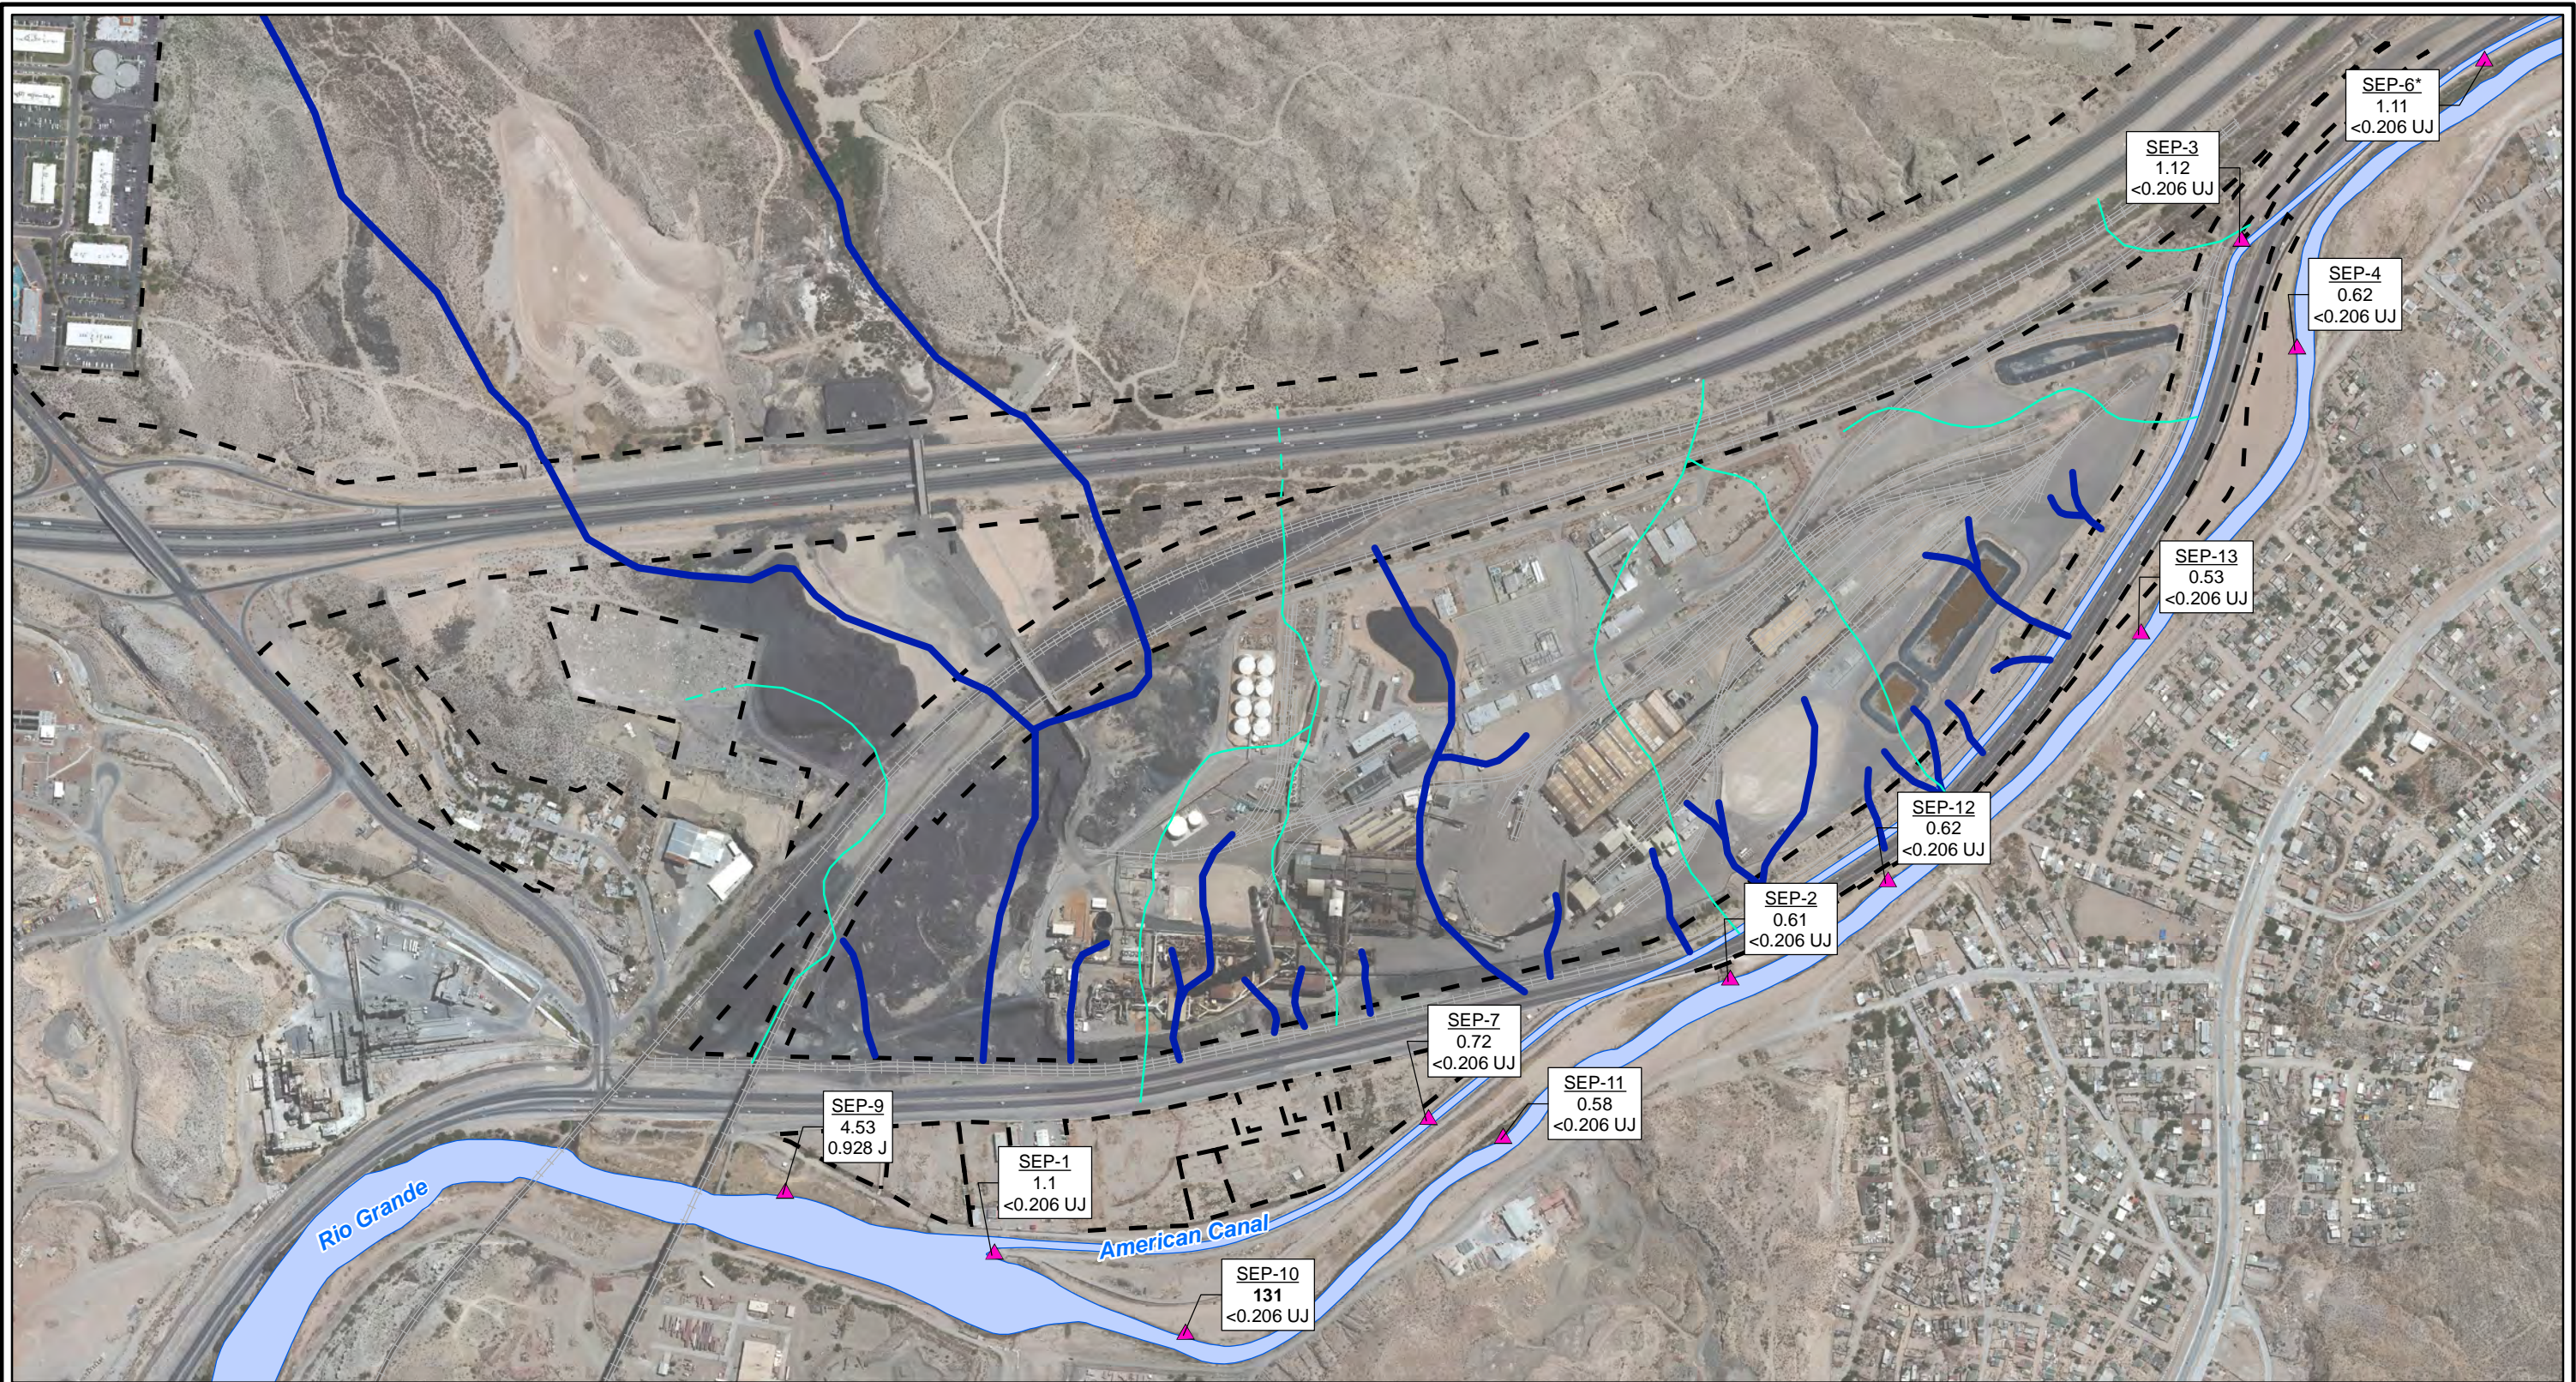
SEP-7	Well ID
0.72	Fall 2010
<0.206 UJ	Fall 2011
