FORMER EL PASO SMELTER SITE
EL PASO, TEXAS

**LEAD DISTRIBUTION IN SOIL
LA CALAVERA**

**FIGURE
4-52**

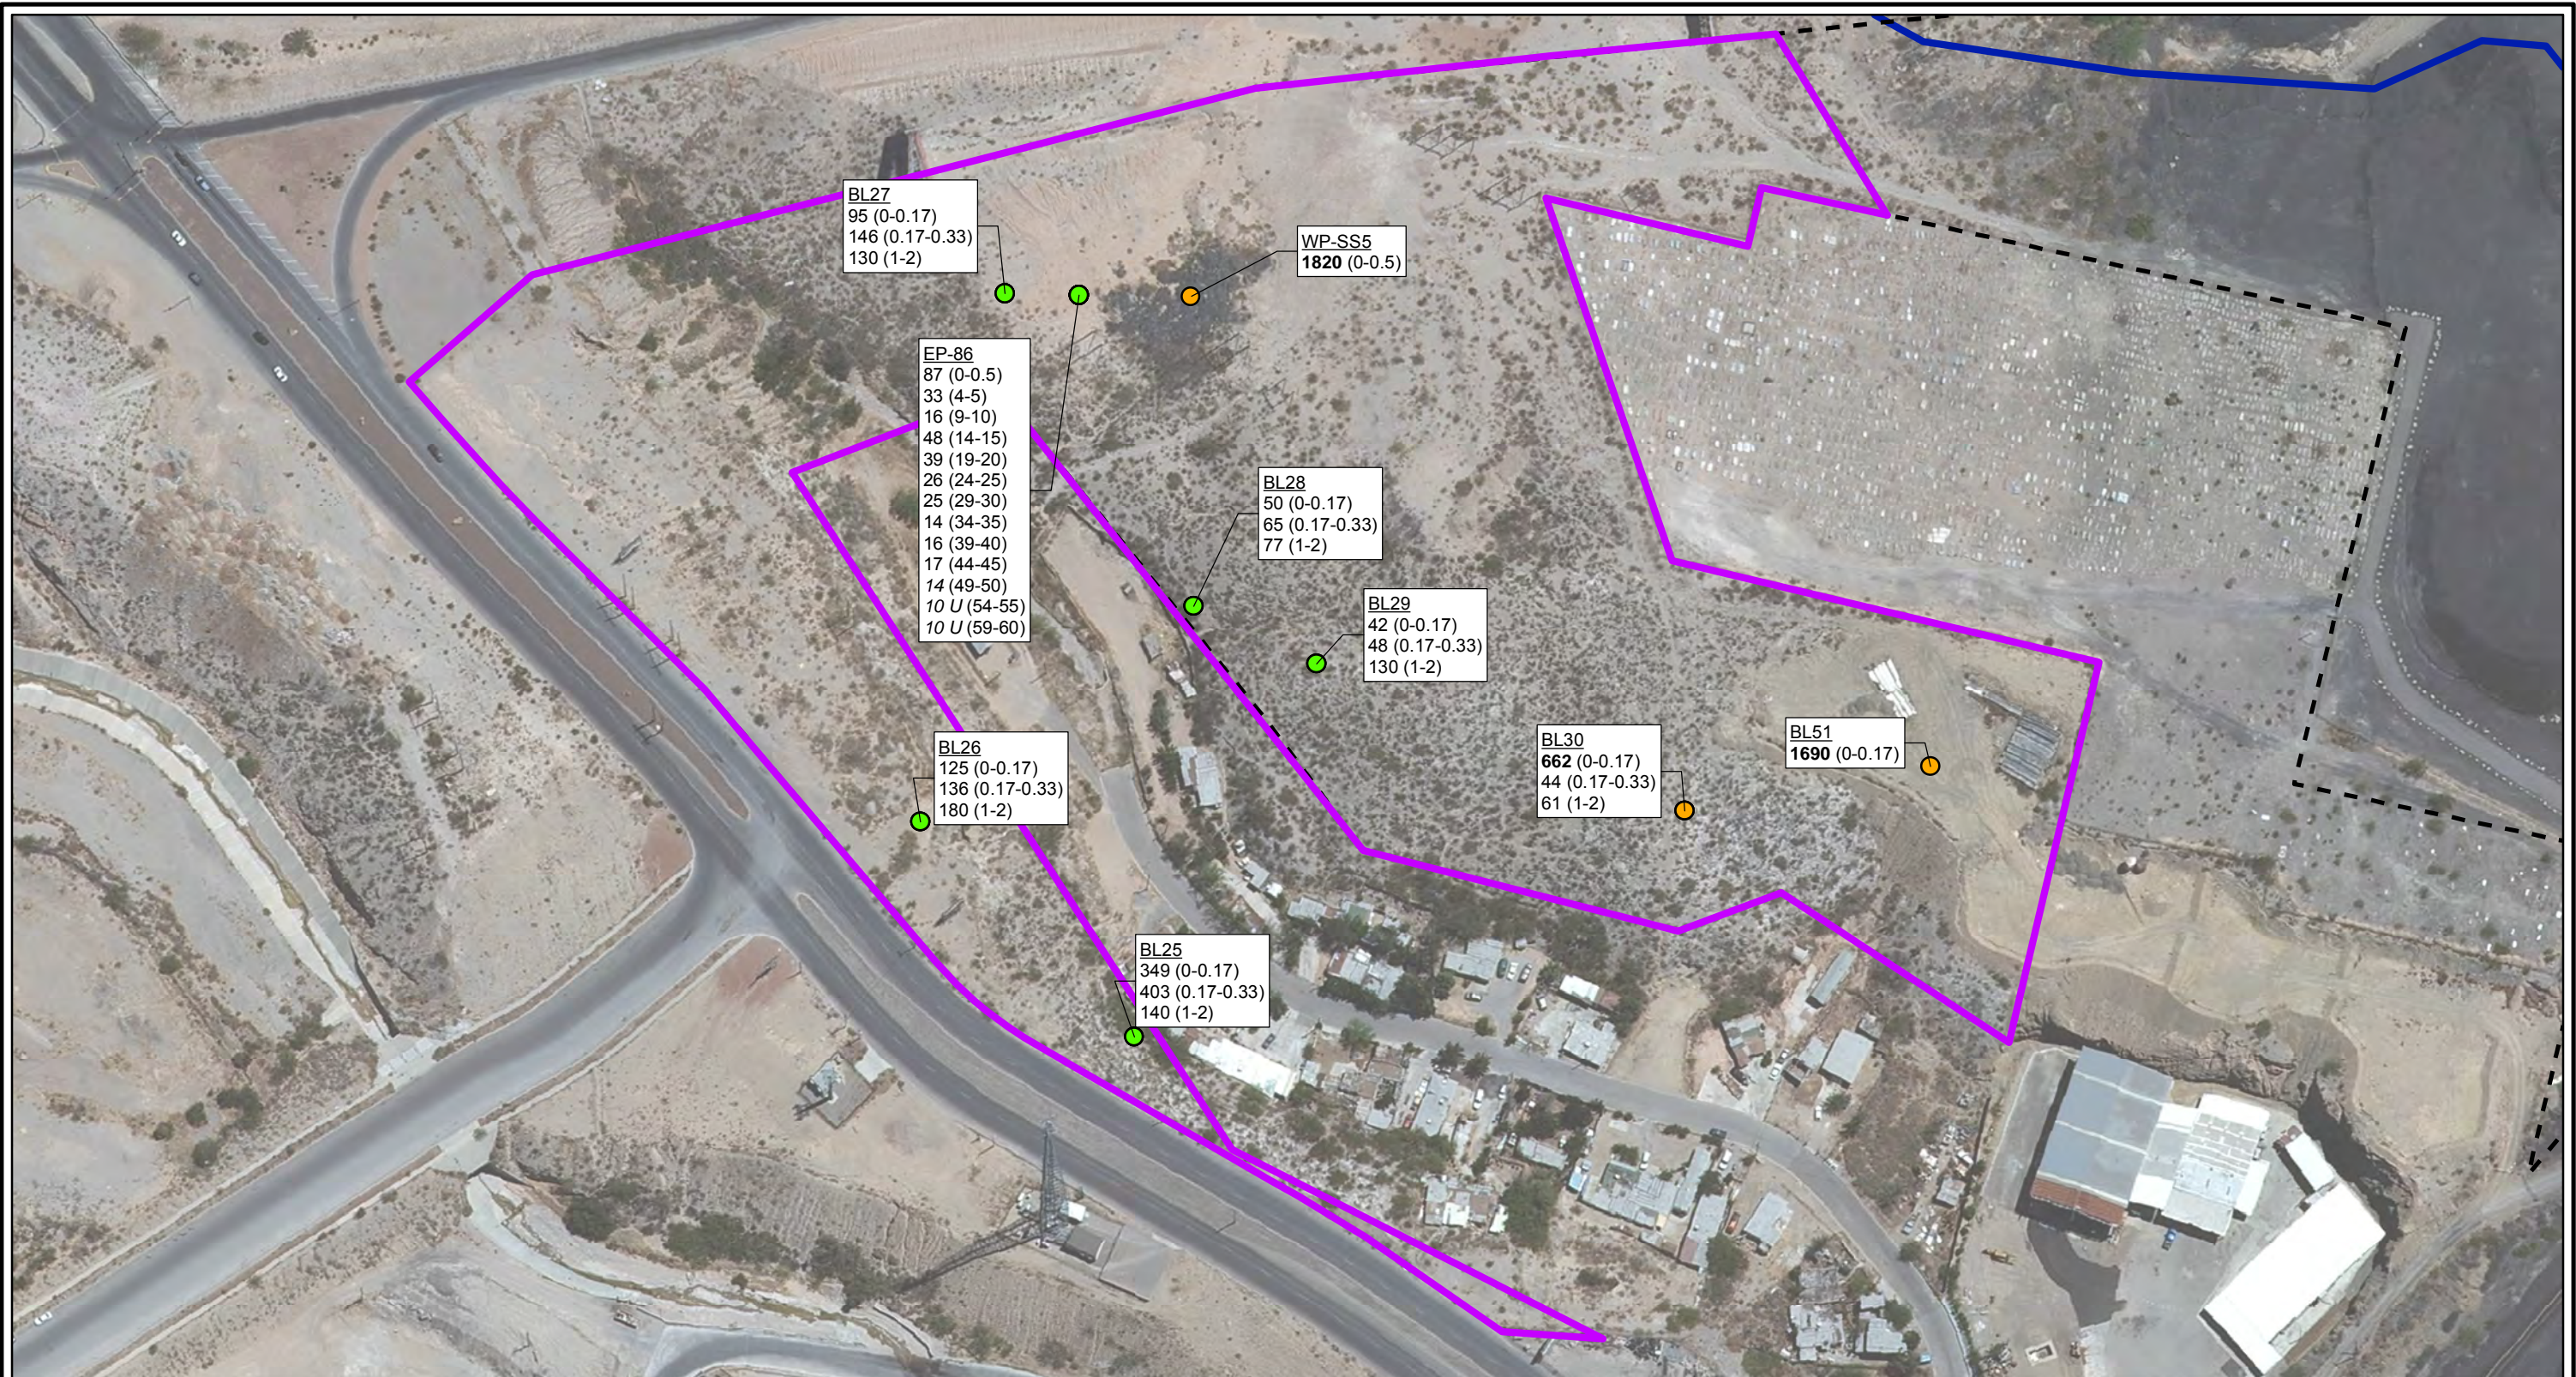
NOTE:
 Screening Level (RRR SAI-Res = 500 mg/kg)
Bolded Value exceeds screening level
Italics indicate below the water table
 J = Estimated Value
 U = Not detected at or above reporting limit
 Date of Aerial Photo: 2009
