FORMER EL PASO SMELTER SITE
EL PASO, TEXAS

**LEAD DISTRIBUTION IN SOIL
PARKER BROTHERS ARROYO/BONEYARD**

**FIGURE
4-26**

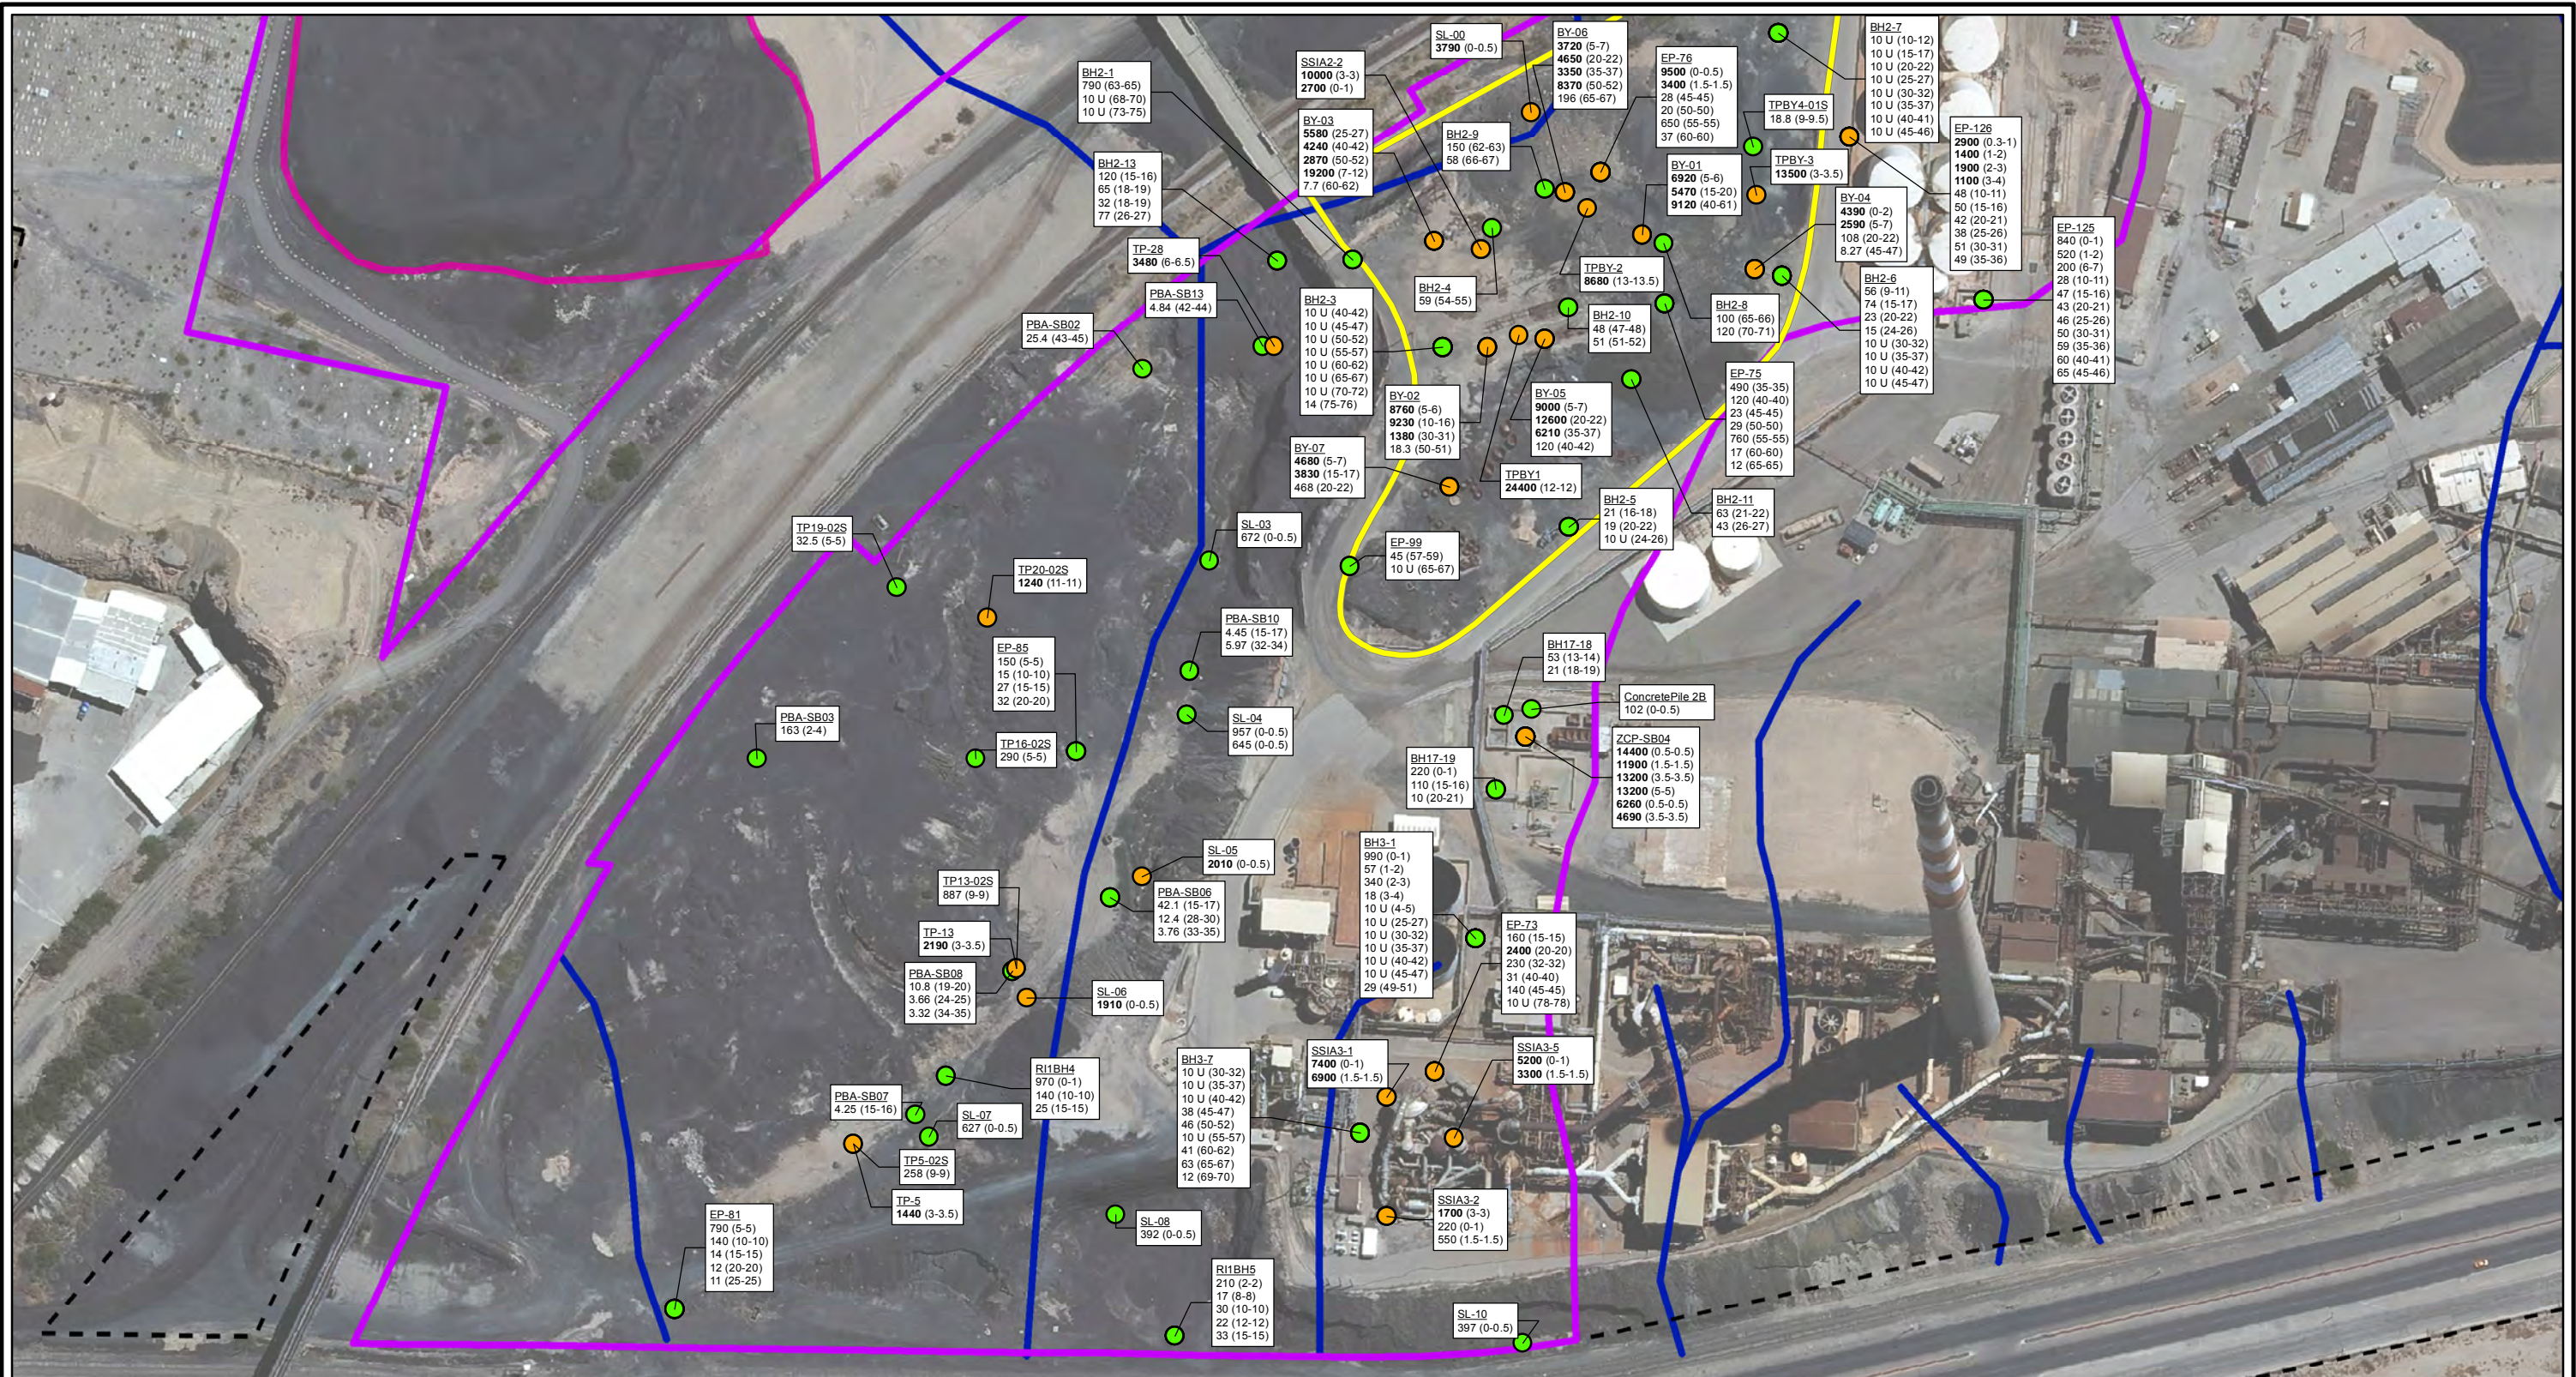
NOTE:
 Screening Level (RRR SAI-Ind = 1000 mg/kg)
Bolded Value exceeds screening level
Italics indicate below the water table
 J = Estimated Value
 U = Not detected at or above reporting limit
 Date of Aerial Photo: 2009
