FORMER EL PASO SMELTER SITE  
EL PASO, TEXAS

**MERCURY DISTRIBUTION IN SOIL  
PARKER BROTHERS ARROYO/FINES PILE**

**FIGURE  
4-27**

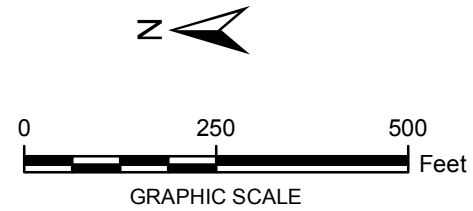
**NOTE:**  
 Screening Level (RRR SAI-Ind = 0.15 mg/kg)  
**Bolded** Value exceeds screening level  
*Italics* indicate below the water table  
 J = Estimated Value  
 U = Not detected at or above reporting limit  
 Date of Aerial Photo: 2009
