FORMER EL PASO SMELTER SITE
EL PASO, TEXAS

**MERCURY DISTRIBUTION IN SOIL
ACID PLANT ARROYO**

**FIGURE
4-48**

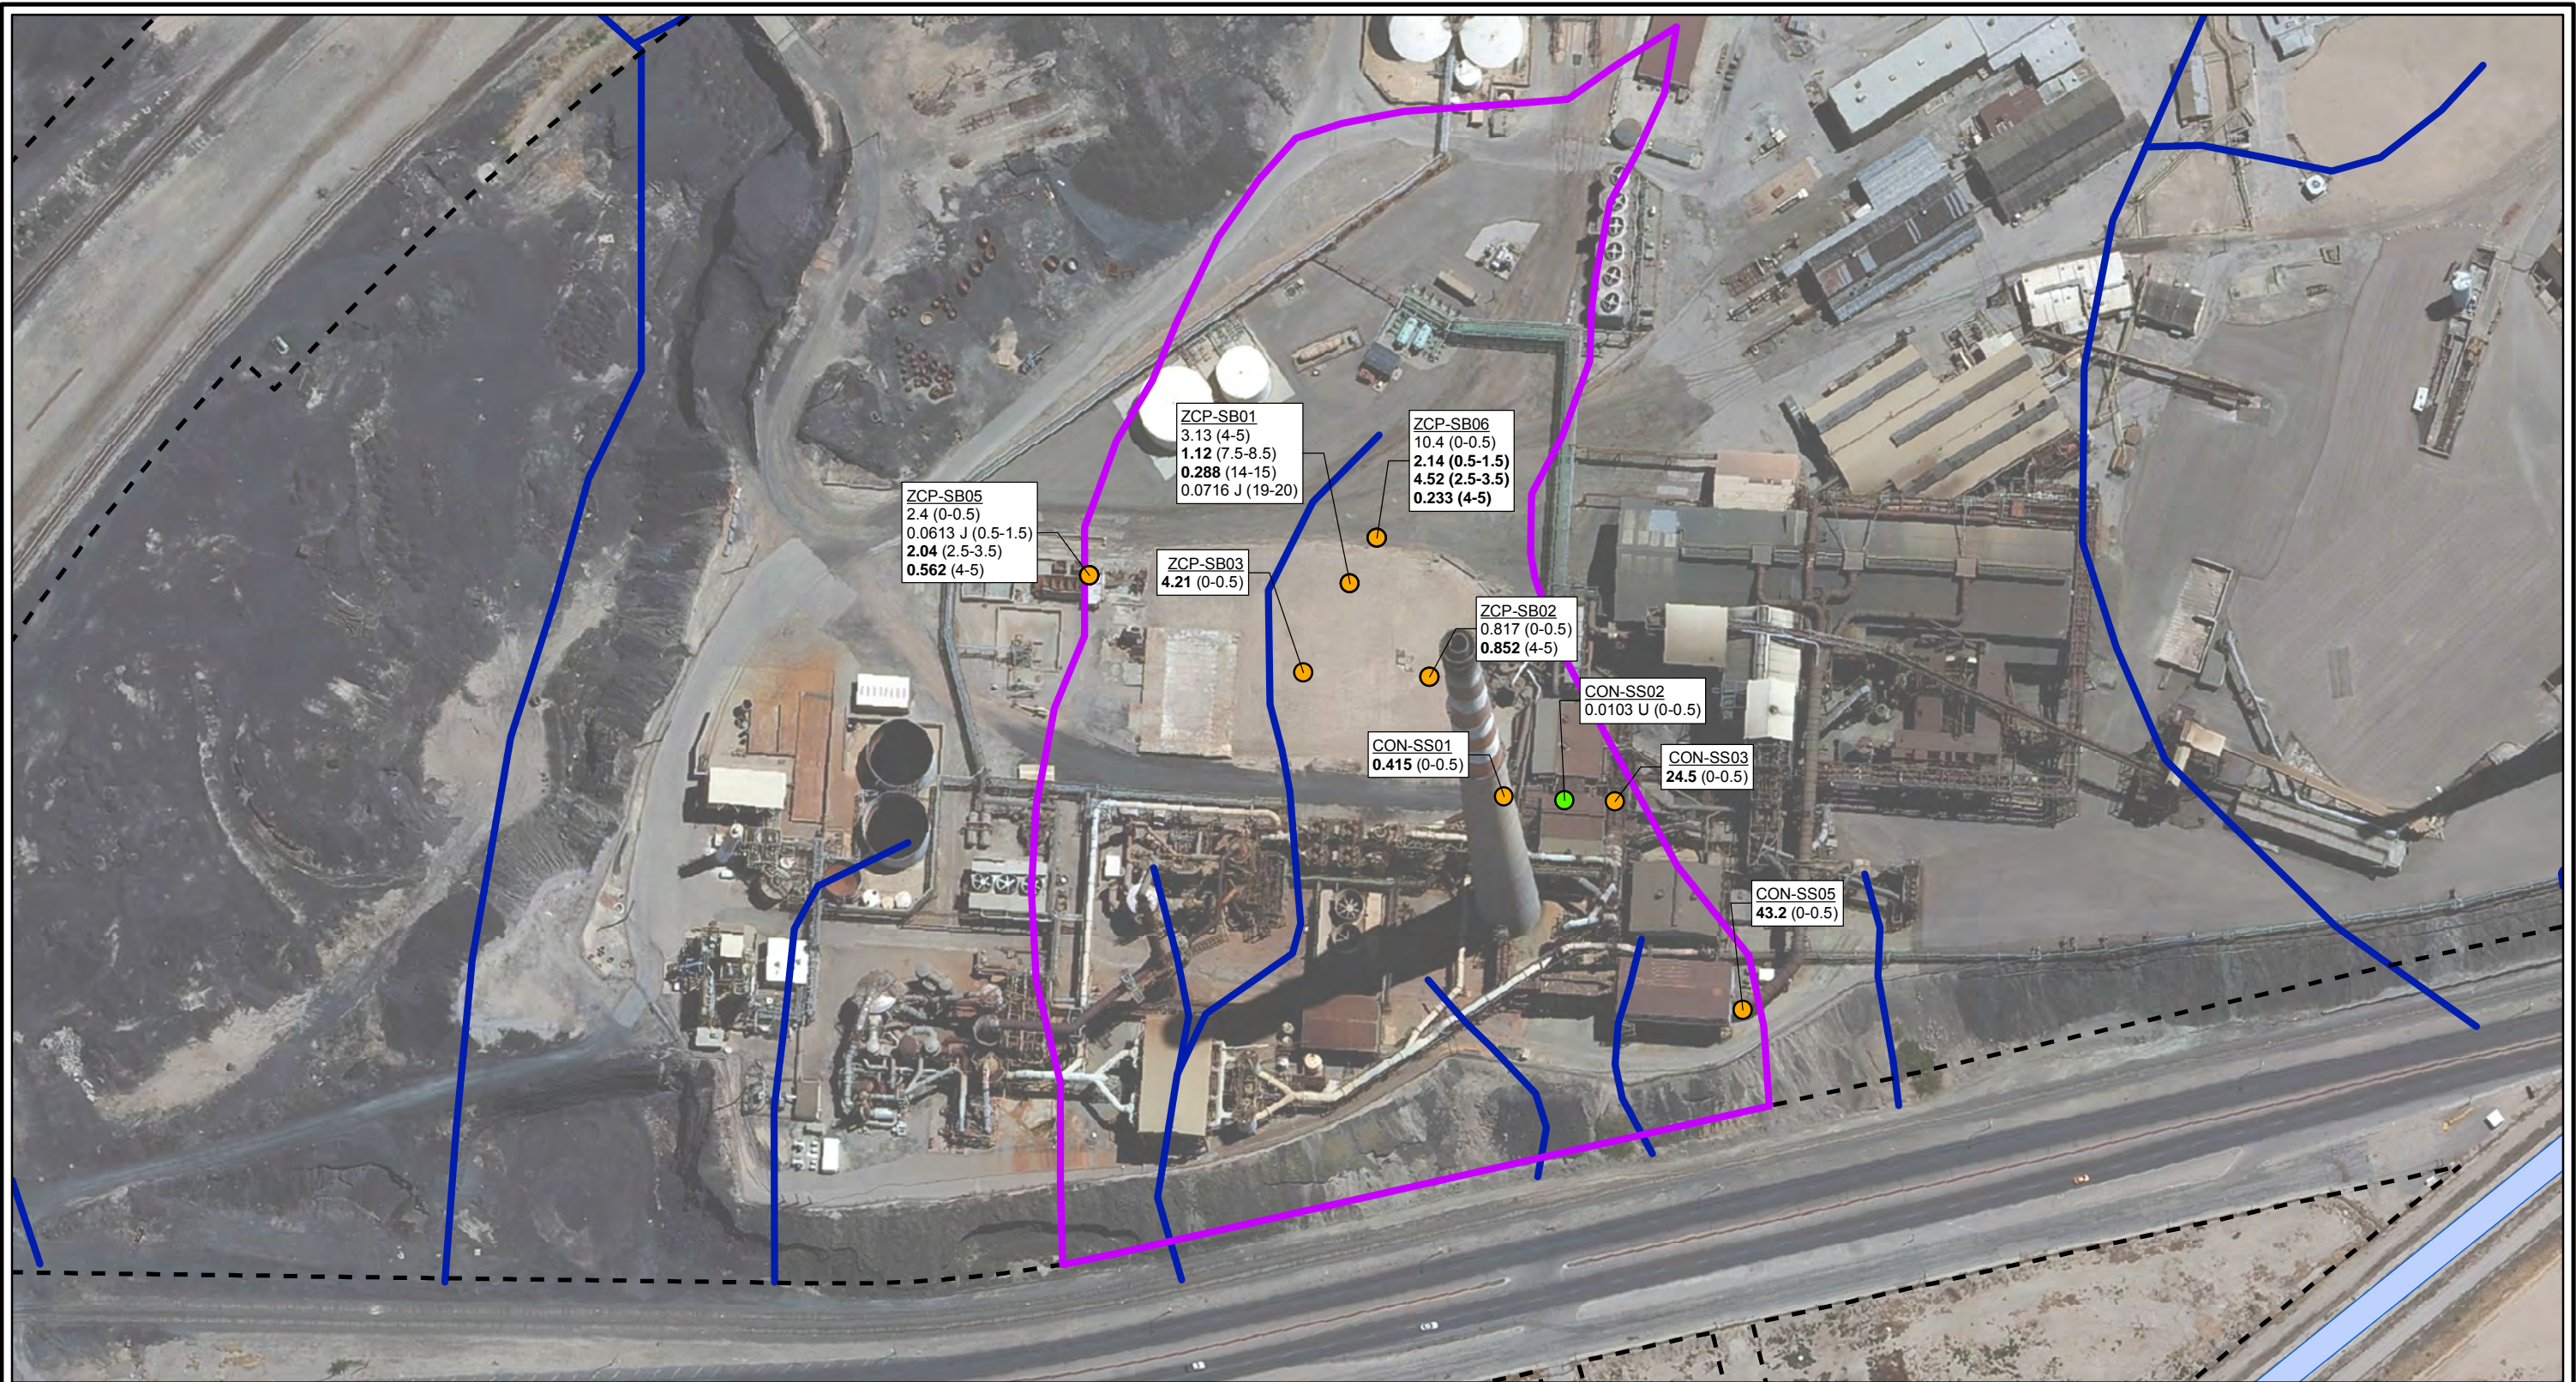
NOTE:
 Screening Level (RRR SAI-Ind = 0.15 mg/kg)
Bolded Value exceeds screening level
Italics indicate below the water table
 J = Estimated Value
 U = Not detected at or above reporting limit
 Date of Aerial Photo: 2009
